The Impact of Radiative Heat Flux from Building Fires on Insurer Certified PIR sandwich panels.

Mostyn Bullock BEng CEng FIFireE

Investigation of performance in real fires

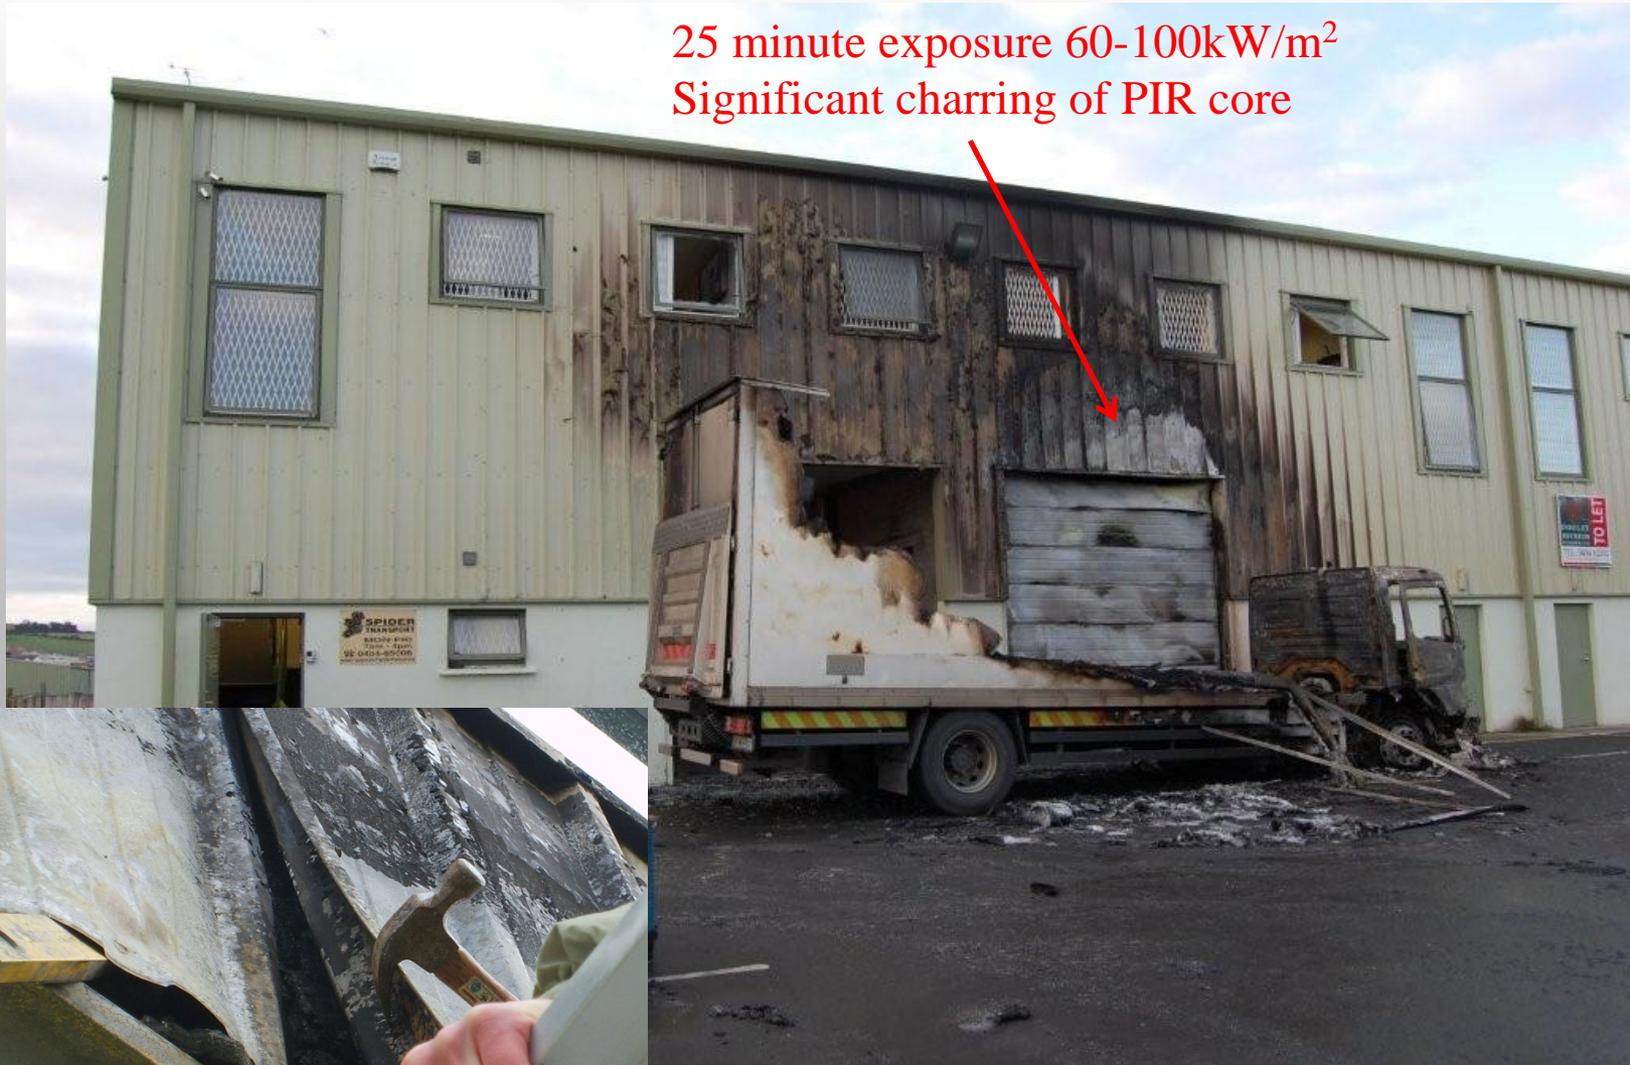
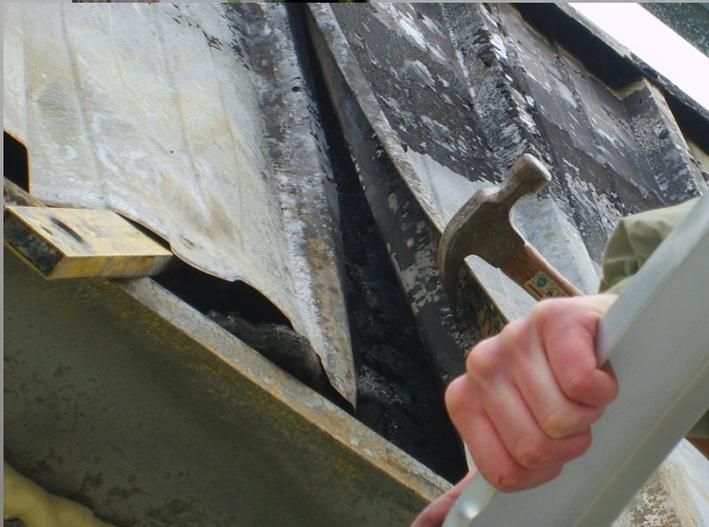
Spider Transport, Ireland - 2008

25 minute exposure 60-100kW/m²
Significant charring of PIR core

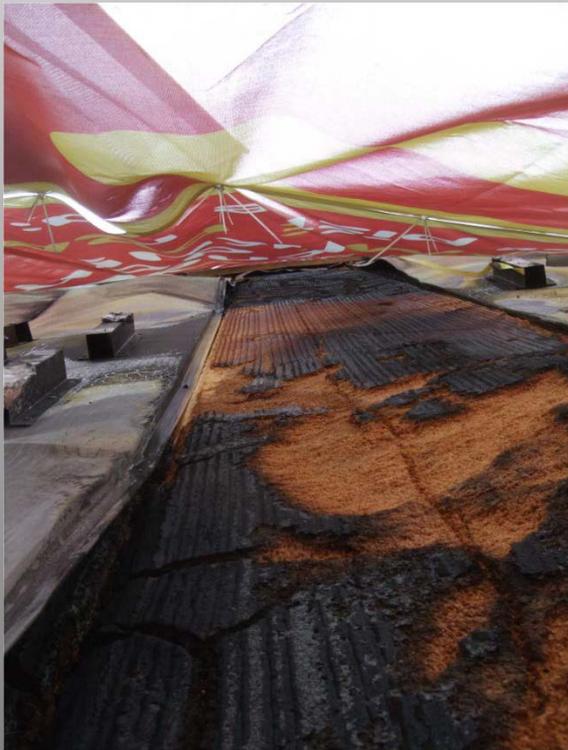
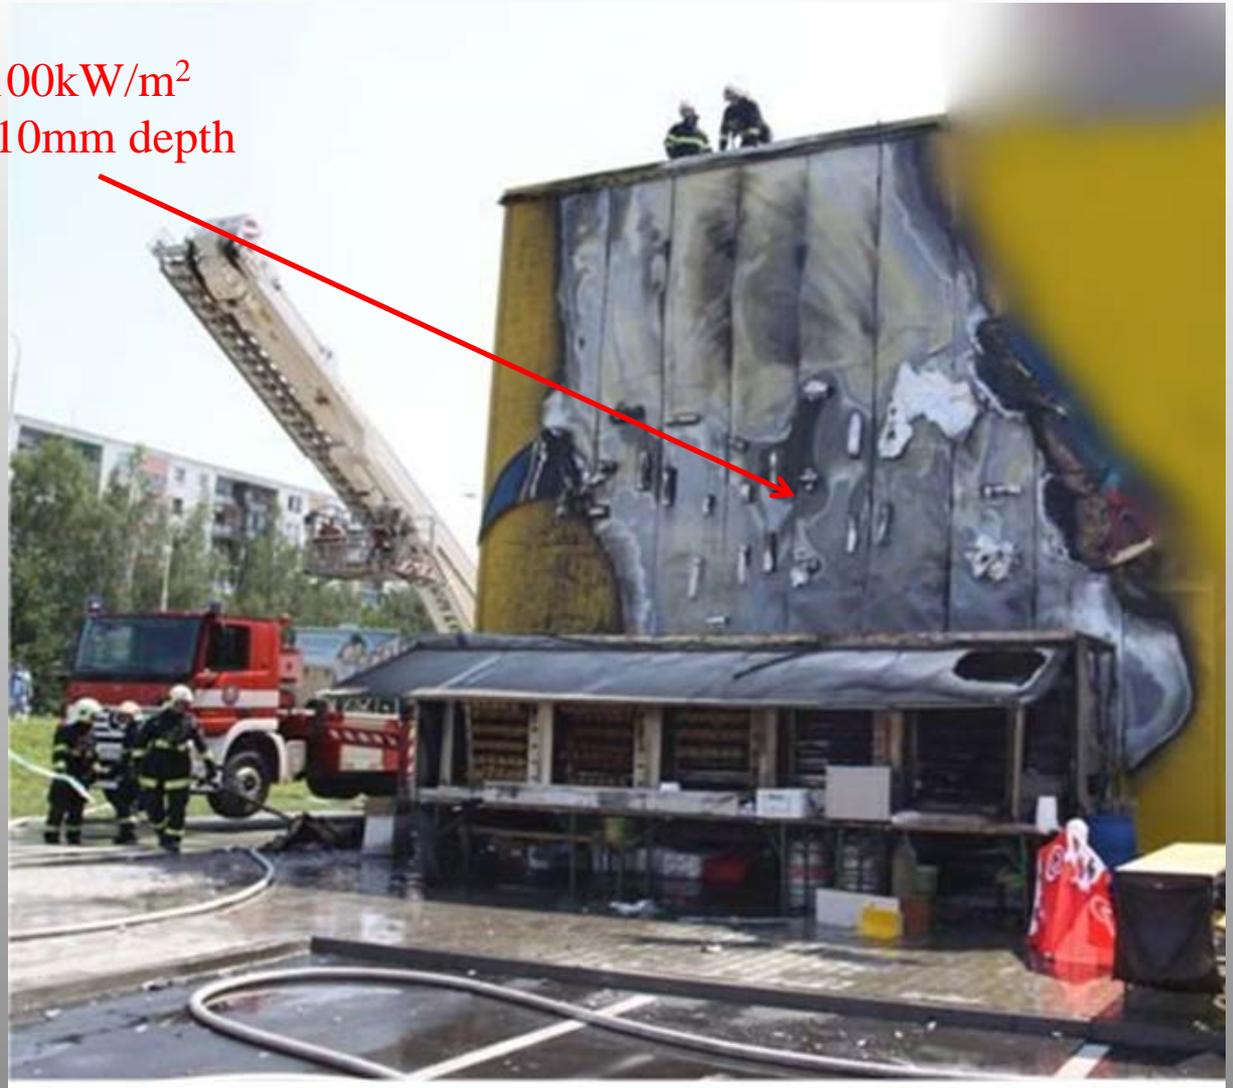
Furniture Store Slovakia - 2012

10 minute exposure 60-100kW/m²
Charring of PIR core to 10mm depth

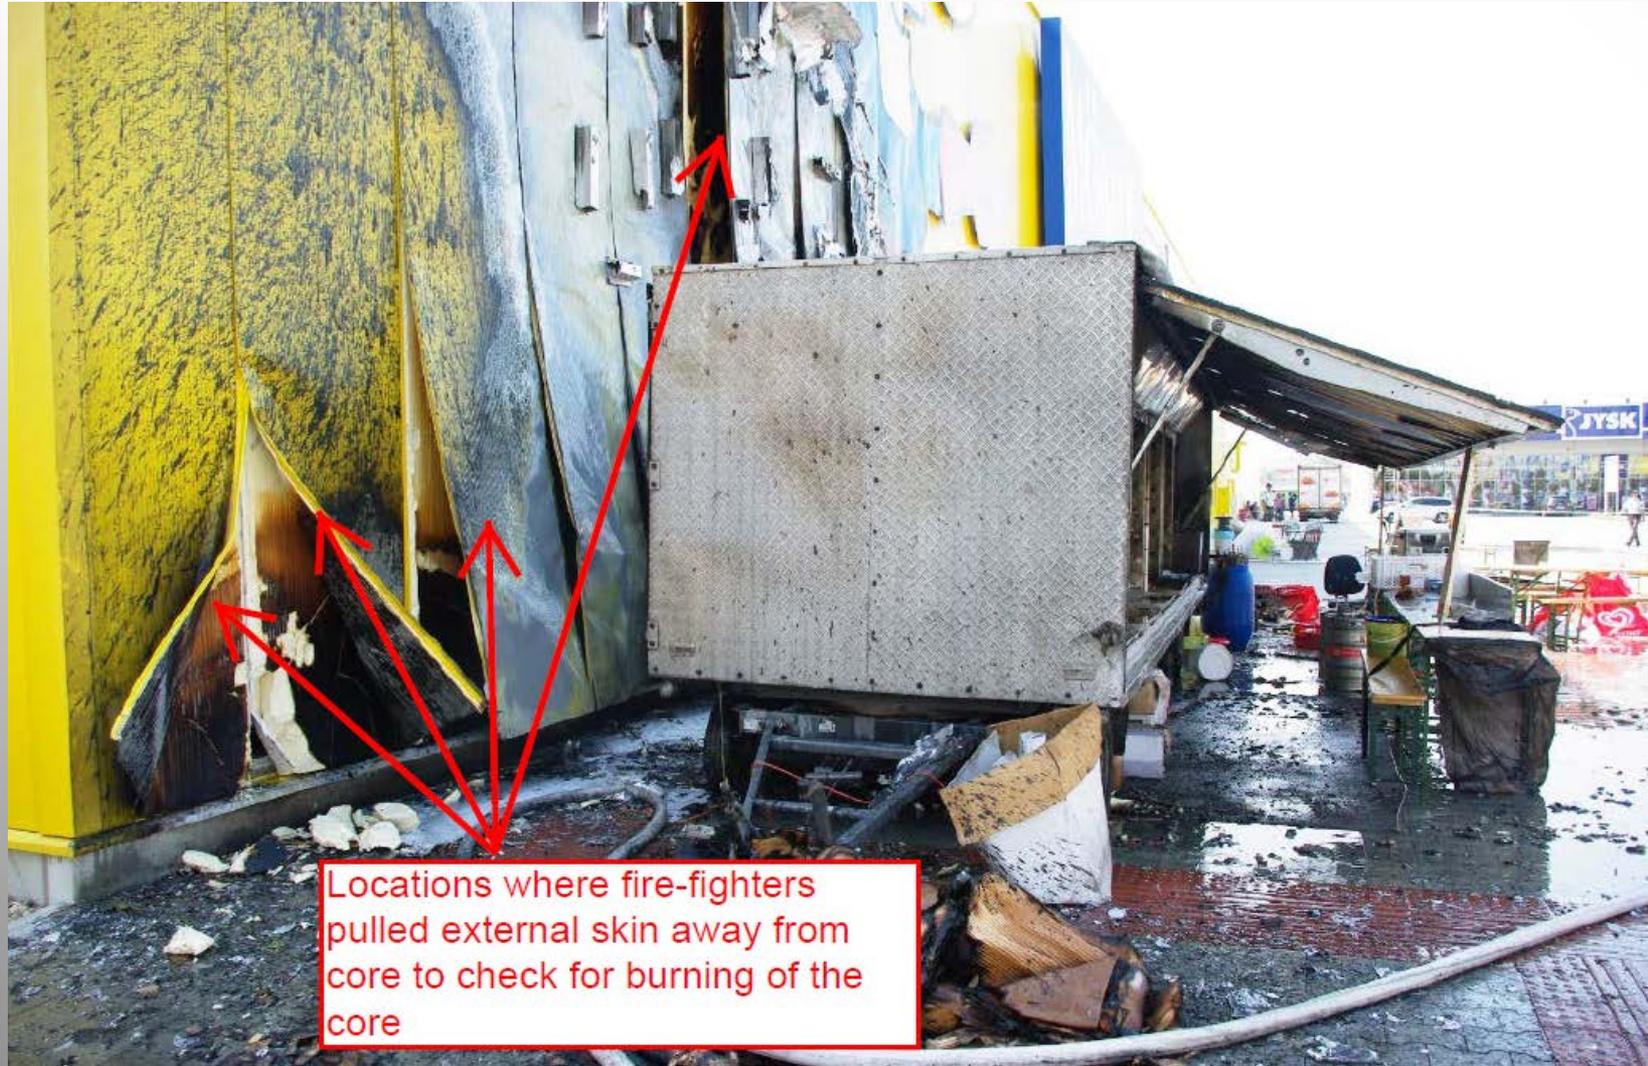
Furniture Store Slovakia - 2012

Locations where fire-fighters pulled external skin away from core to check for burning of the core

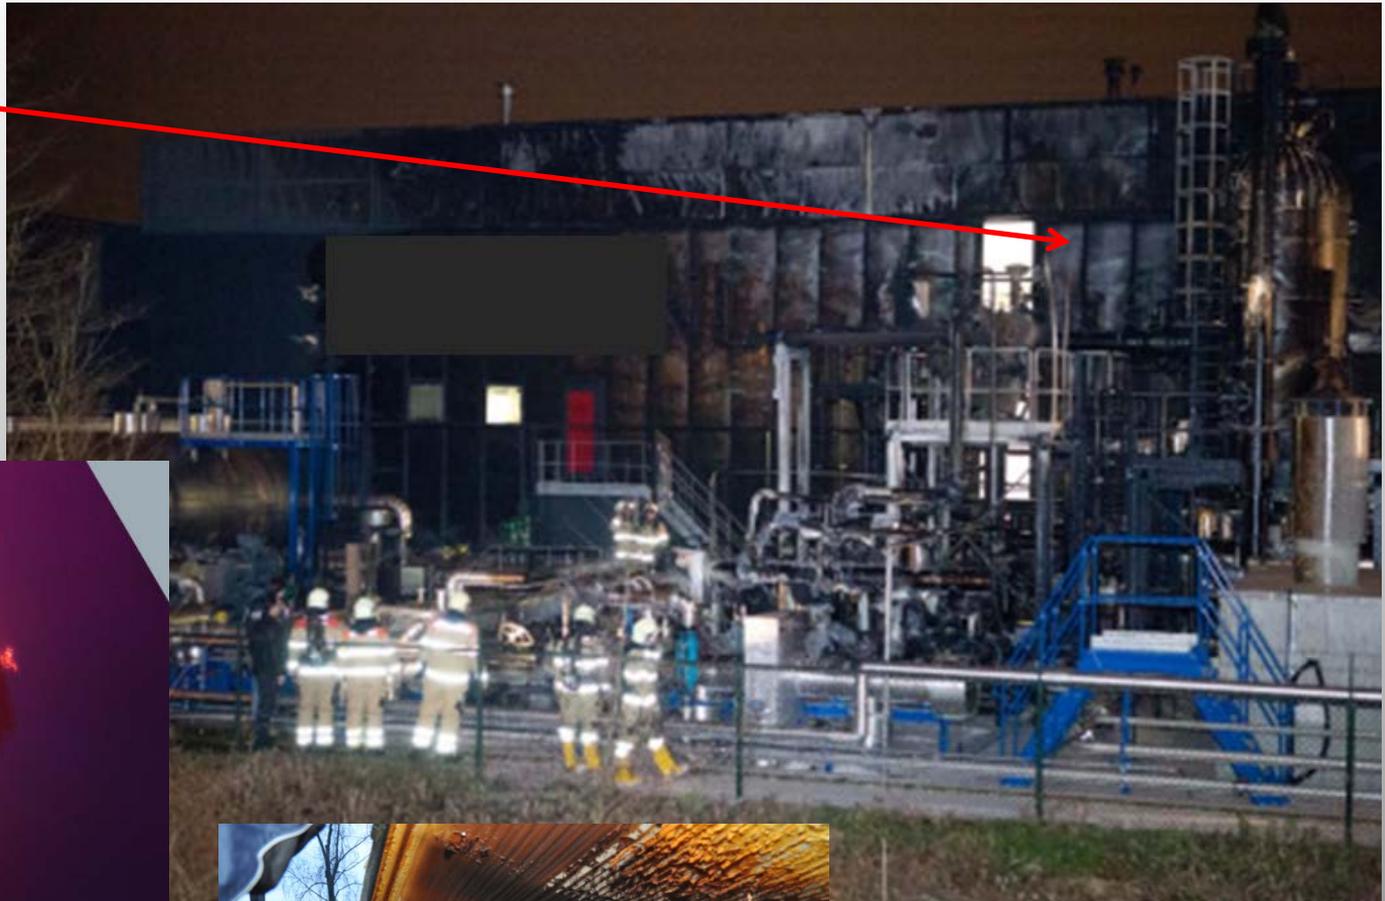
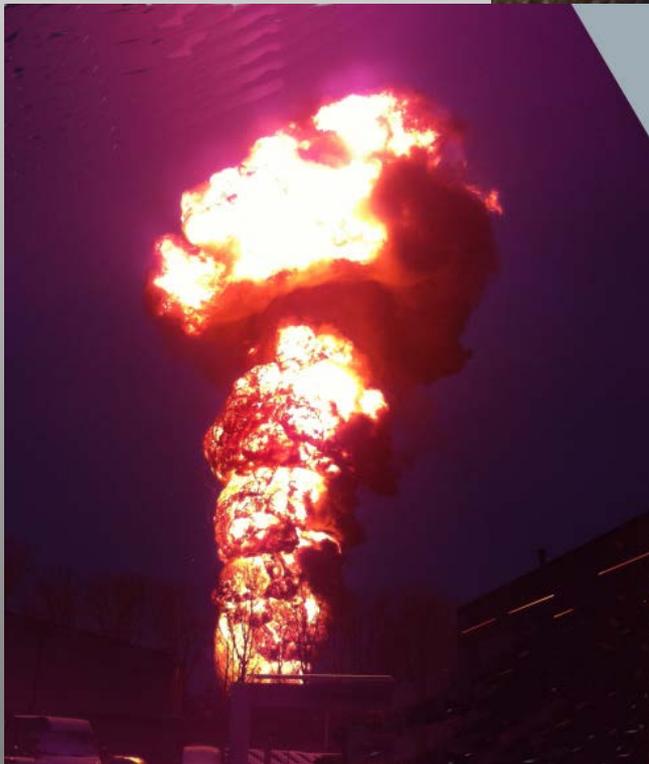
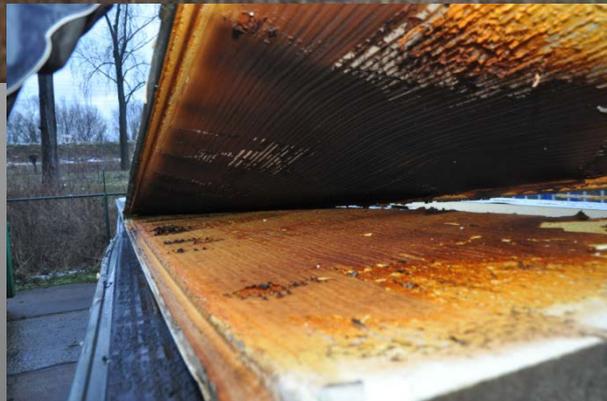
Oil facility, Netherlands - 2013

8 minute exposure
24kW/m²
Surface charring of
PIR core

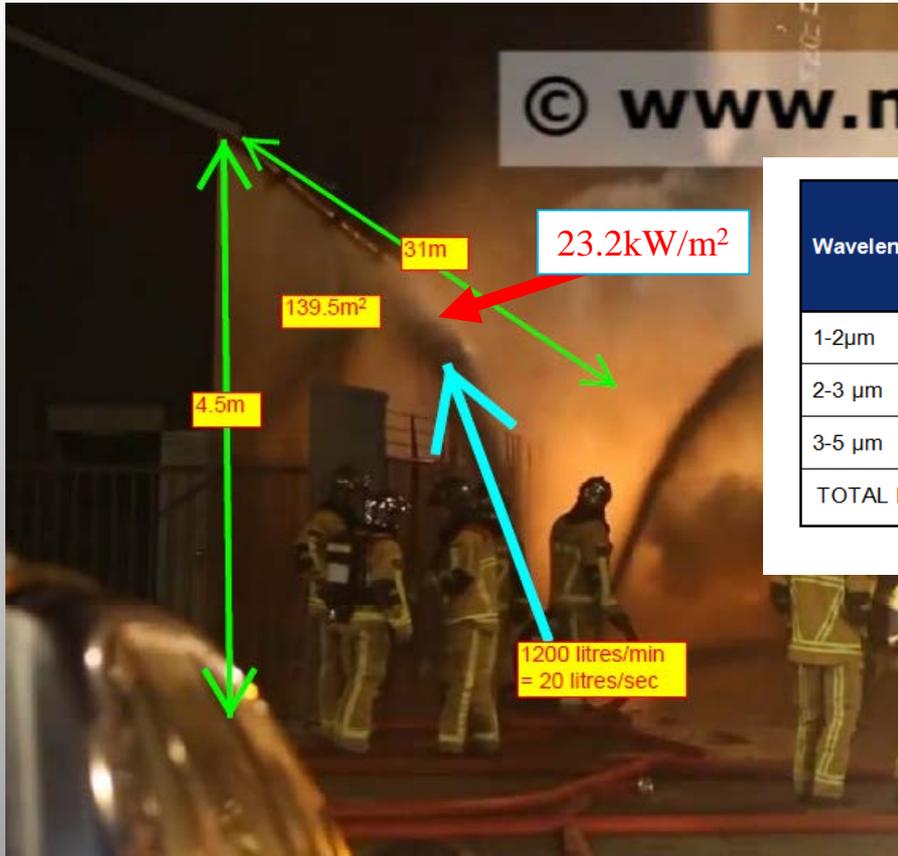
Heining, Netherlands - 2013

Assume water film spread evenly over wall surface = 0.0143cm/sec applied

Wavelength	Relative % of R _e	Incident heat flux at this wavelength range, kW/m ²	Absorption coefficient, cm ⁻¹	Residual Heat Flux at water/surface interface, kW/m ²
1-2µm	25.2	5.85	1	5.07
2-3 µm	34.7	8.05	100	1.93
3-5 µm	40.1	9.30	1000	5.7 x 10 ⁻⁶
TOTAL Incident Heat Flux		23.2	TOTAL Residual Heat Flux 7.0

Based on 4.5m wall height the flow time from top of wall to ground = 1 second (approx).

In this 1 second the water film absorbs:
 $23.2 - 7.0 = 16.2\text{KJ/m}^2$

Based on specific heat capacity of water:
 Temp rise = 27°C

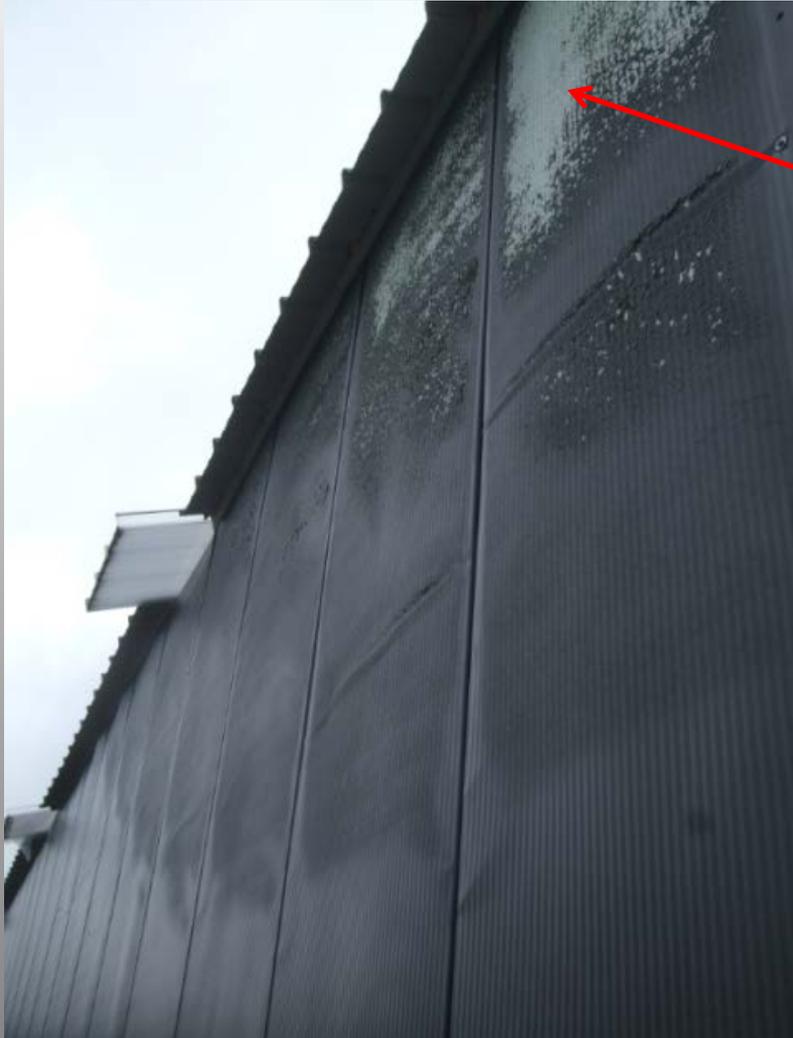
Heining, Netherlands - 2013

15 minute exposure ?
17kW/m² ?
Charring of PIR core?
(yet to be dismantled & inspected)

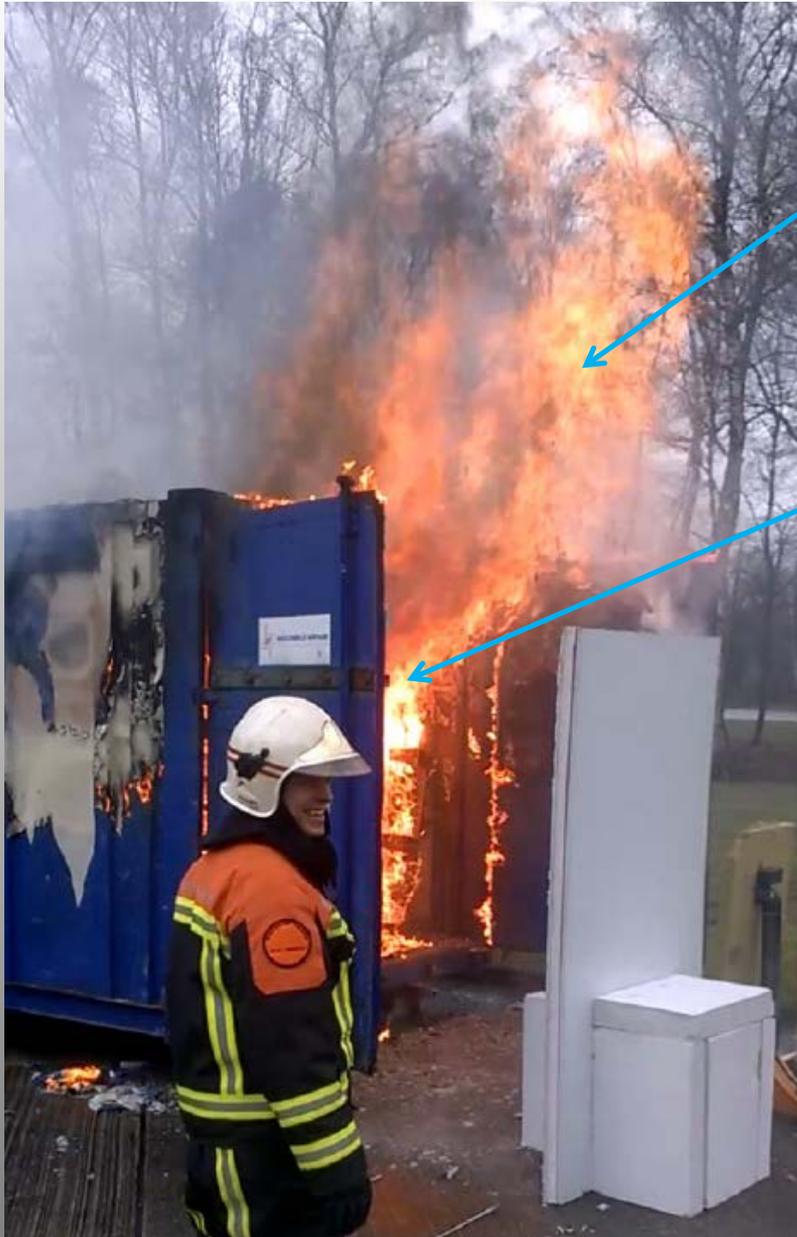
Troned – March 2014

Plume:

Emissivity = 0.423

Heat Flux emitted = 34.5kW/m²

Opening:

Emissivity = 1.0

Heat Flux emitted = 84kW/m²
